Manhole Inspection Summary

Manhole # S25E__030MH

Insp Date: **8/7/07 8:29 AM**

Location Address: **1212 CAREY-ALLEY-CARROLLTON** Cross Street: **SARATOGA ST**

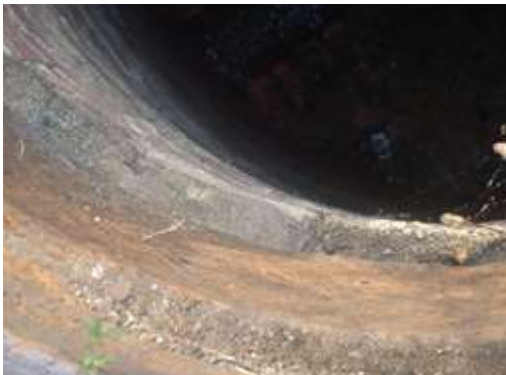
Defect 2

Frame Offset: **1** (in.) Condition: ☒ Sound ☐ Cracked ☐ Leaks

FRAME OFFSET

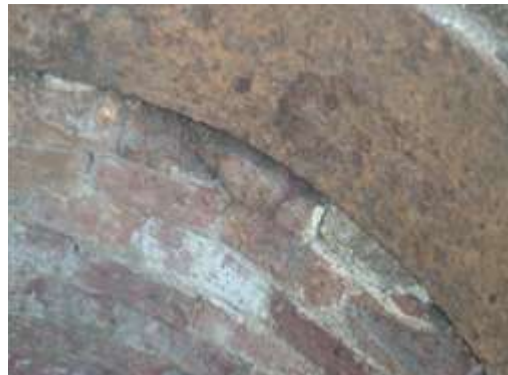
Defect 3

Corbel Material: **Brick** ☐ Parged Type: **Concentric/Eccentric**
Condition: ☐ Sound ☐ Cracked ☐ Root Intrusion ☐ Loose Brick ☒ **Deteriorated**
Infiltration: ☒ None ☐ Joint ☐ Cracks ☐ Mortar ☐ Roots ☐ Wall

DETERIORATION OF CORBEL

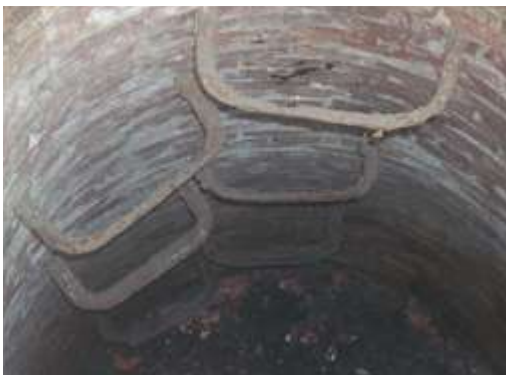
Defect 1

Steps Count: **6** Missing: **0** ☒ **Corroded**

CORRODED STEPS

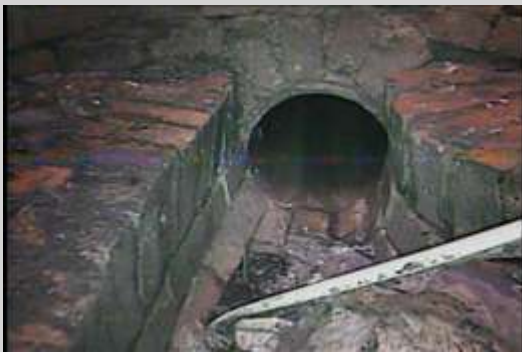
12 O'Clock Outflow

8 in. Circular Gravity Sewer
Pipe Out @ 12 O'Clock

Pipe Height: **8.4** (in.) Rod and Bar (Angled)
Pipe Material: **Clay** ☐ Pipe Lined
Invert Depth: **9.42** (ft.) Flow Characteristics: **Slow**
Deposits: ☒ None ☐ **Mud** ☐ Sludge ☐ Debris ☐ Grease
Silt Depth: (in.) Deposits Extent:
Infiltration: **None** Pipe Seal Cond: **Sound**

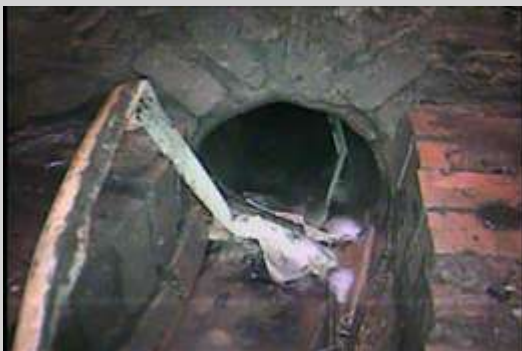
3 O'Clock Inflow

8 in. Circular Gravity Sewer
Pipe In @ 3 O'Clock

Pipe Height: **8.4** (in.) Rod and Bar (Angled)
Pipe Material: **Clay** ☐ Pipe Lined
Invert Depth: **8.95** (ft.) Flow Characteristics: **Slow**
Deposits: ☐ None ☐ **Mud** ☒ **Sludge** ☐ Debris ☐ Grease
Silt Depth: **2** (in.) Deposits Extent: **Light**
Infiltration: **None** Pipe Seal Cond: **Sound**

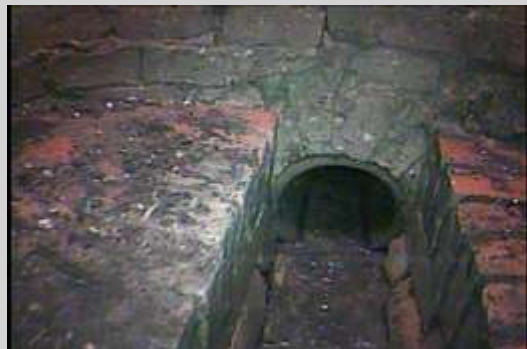
6 O'Clock Inflow

8 in. Circular Gravity Sewer
Pipe In @ 6 O'Clock

Deposits: ☐ None ☒ **Mud** ☐ Sludge ☐ Debris ☐ Grease

Silt Depth: **1** (in.) Deposits Extent: **Light**
